REPORT BMS34

Performance Test of Floor
Coverings for Use in Low-
Cost Housing: Part 1

PERCY A. SIGLER *and*
ELMER A. KOERNER

NATIONAL
BUREAU OF STANDARDS

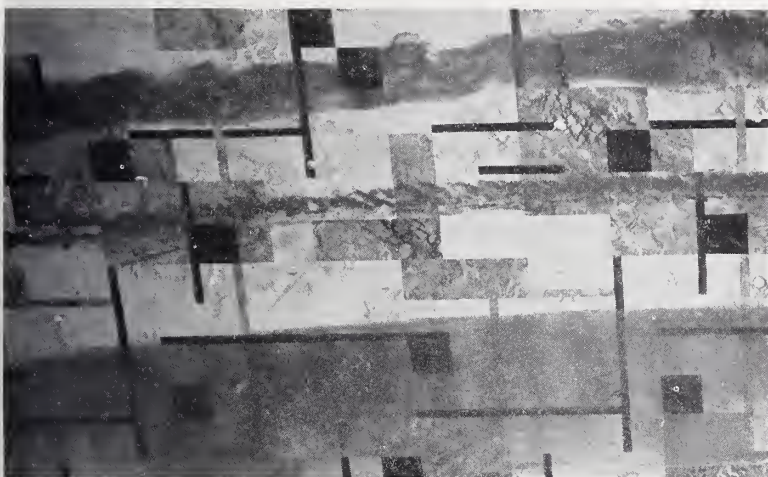
The inlaid felt-base floor coverings, test panels 9, 10, 11, and 12 (see figs. 10, 11, 12, and 13), were in unserviceable condition at the end of the performance test, with the possible exception of panel 9-L. Failures in adhesion to the subfloors and blisters in the floor coverings occurred along the paths of the truck wheels. The metal truck wheels depressed the floor coverings to a moderate degree on both a concrete subfloor and a wood subfloor. The floor coverings were fractured to a considerable extent by the metal truck wheels. There was evidence of some separation of the linoleum composition from the felt backing in panel 9-R.

FIGURE 10.—*Inlaid felt base on concrete subfloor (test panel 9-L).*

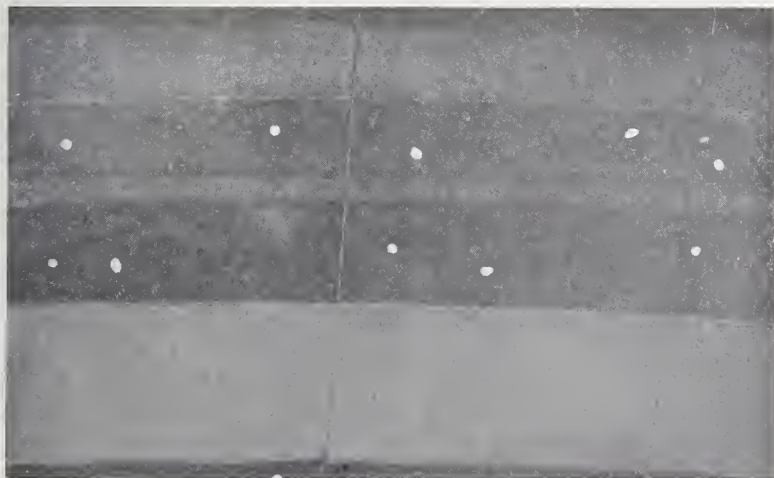
FIGURE 17.—*1/8-in. pressed fiberboard on wood subfloor (test panel 18-R).*

The $\frac{1}{8}$ -in. pressed fiberboard, test panels 17 and 18 (see fig. 17), was in serviceable condition at the end of the performance test, although the fiberboard was appreciably worn by the abrasive action of the walking wheel. Over a concrete subfloor the fiberboards, when first installed, showed a tendency to warp, resulting in some loose boards. There was evidence of extensive failure in adhesion to the wood subfloor in panel 18-L, permitting the tiles to chatter when tapped on the surface, and under the action of the metal truck wheels the adhesive was pulverized and dusted out at the joints of the boards. The fiberboard did not appear to be compressed or fractured by the metal truck wheels, although it showed some deflection over a wood subfloor.

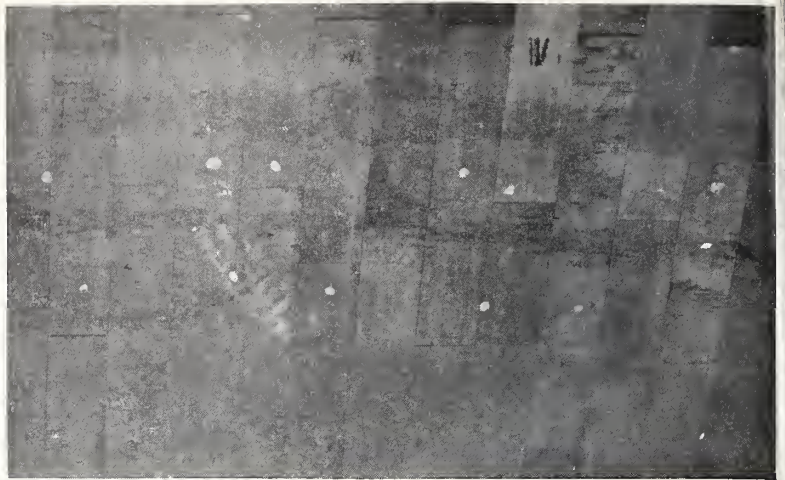
FIGURE 18.— $\frac{25}{32}$ -in. short-strip maple
on concrete subfloor (test panel 19-R).

The short-strip maple flooring, test panel 19 (see fig. 18), was in very good condition except for some failure in adhesion to the concrete subfloor. In panel 19-L the maple expanded across the grain and formed an arch approximately one-eighth of an in. above the concrete subfloor in the central portion of the track. In panel 19-R some of the maple strips shifted toward the inside of the track, leaving a slight separation in some of the end joints. The maple was moderately depressed by the metal truck wheels. There was no evidence of fracture or splintering of the maple.

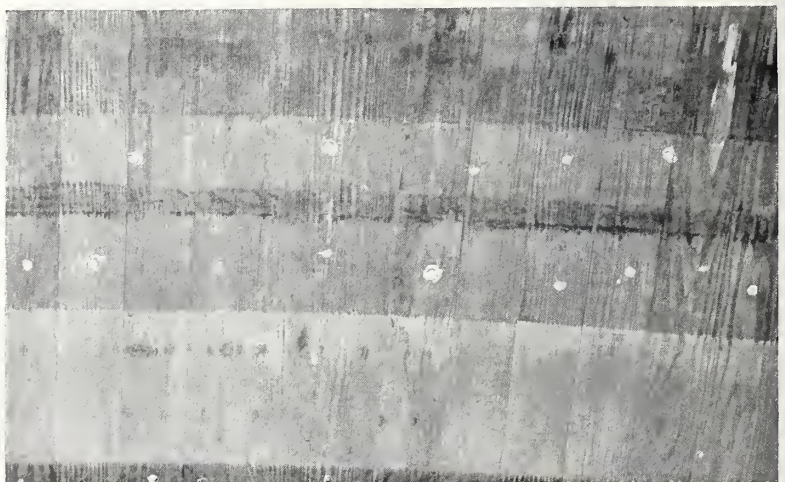
FIGURE 20.— $\frac{25}{32}$ -in. strip yellow pine
on wood sleepers (test panel 20-R).

The strip yellow-pine flooring, test panel 20-R (see fig. 20), was in fair condition at the end of the performance test. The strips remained rigidly bonded to the sleepers. The metal truck wheels depressed the yellow pine to an appreciable degree and caused some fracturing and splintering of the flooring.
